## **HULLBUG TECHNOLOGY DEVELOPMENT FOR UNDERWATER HULL CLEANING, FINAL REPORT**

**SEAROBOTICS**

**14/05/2015**

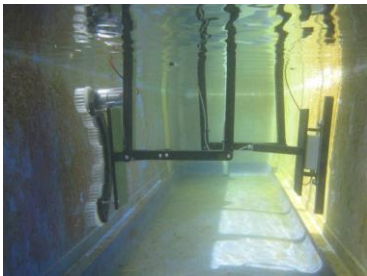
Gantry Grooming Tool

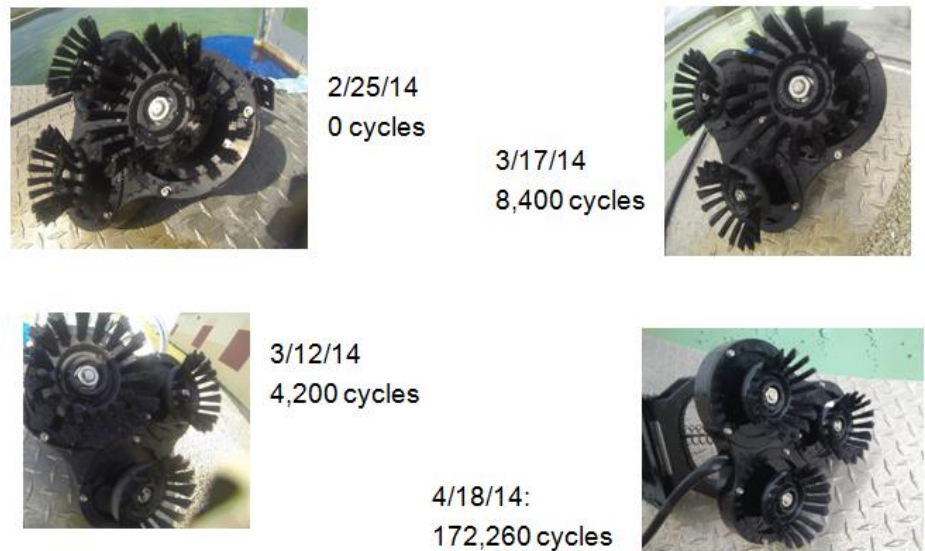
The following pictures illustrate the degree of wear experienced by the brushes over an extended period.

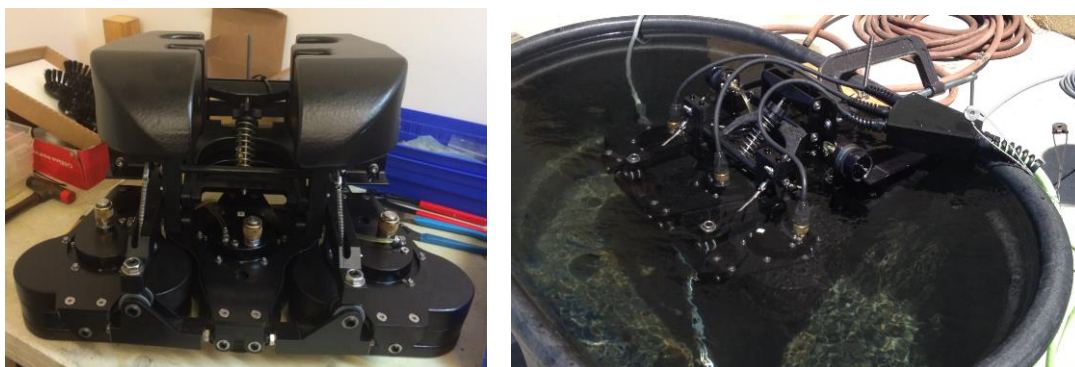
After completion of the 3 headed tool design, fabrication and testing effort the Navy engaged FIT and authorized SRC to build a 9 headed tool that would mount on a FIT supplied vehicle. The 9 headed tool consisted of three, 3 headed tools arranged, side by side, in a fashion that met FIT's requirement of head to head center distance.

**FIT Grooming Tool and In-water Testing**

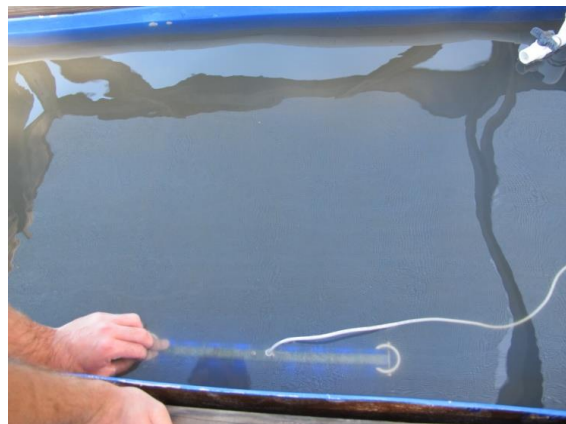
Turbid Water Testing

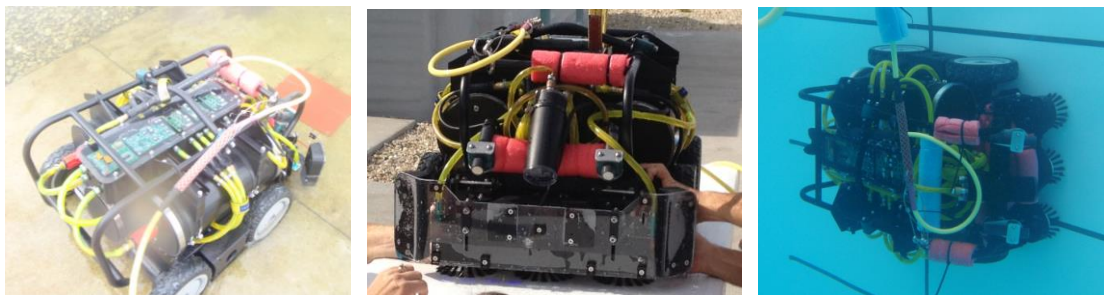
**FIT Test Vehicle**
